BIKINI SCIENTIFIC RESURVEY. VOLUME III. REPORT OF THE DIRECTOR --ETC(U)
DEC 47

Bikini Scientific Resurvey, Annex II

PILOTFISH: GENERAL DESCRIPTION OF DAMAGE

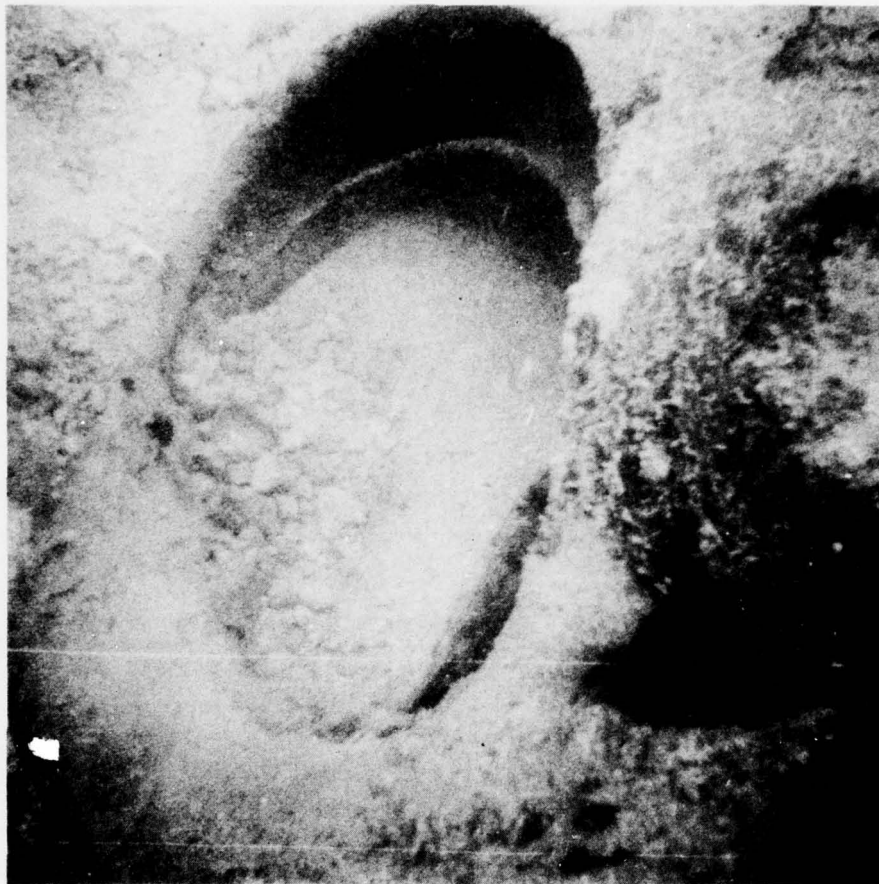
Figure 3. PILOTFISH. Main engine exhaust, frame No. 96 to No. 97, port. ABCR Photo No. 6039-6.

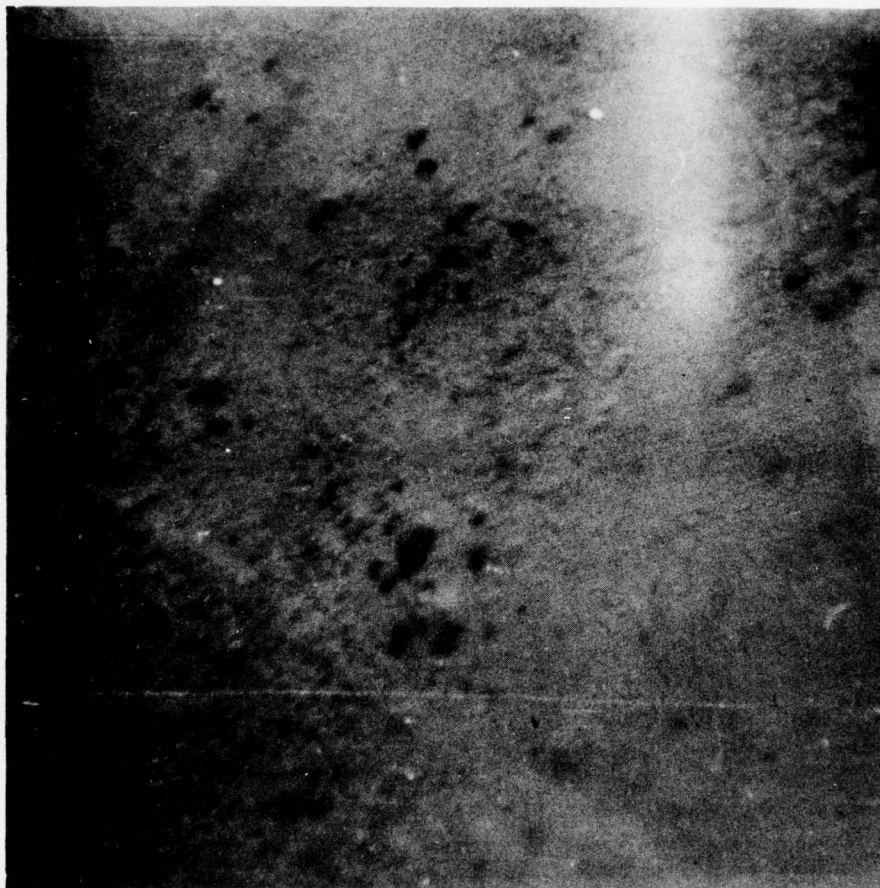
Figure 4. PILOTFISH. Weld in ballast tank, about frame No. 79. ABCR Photo No. 6039-20.

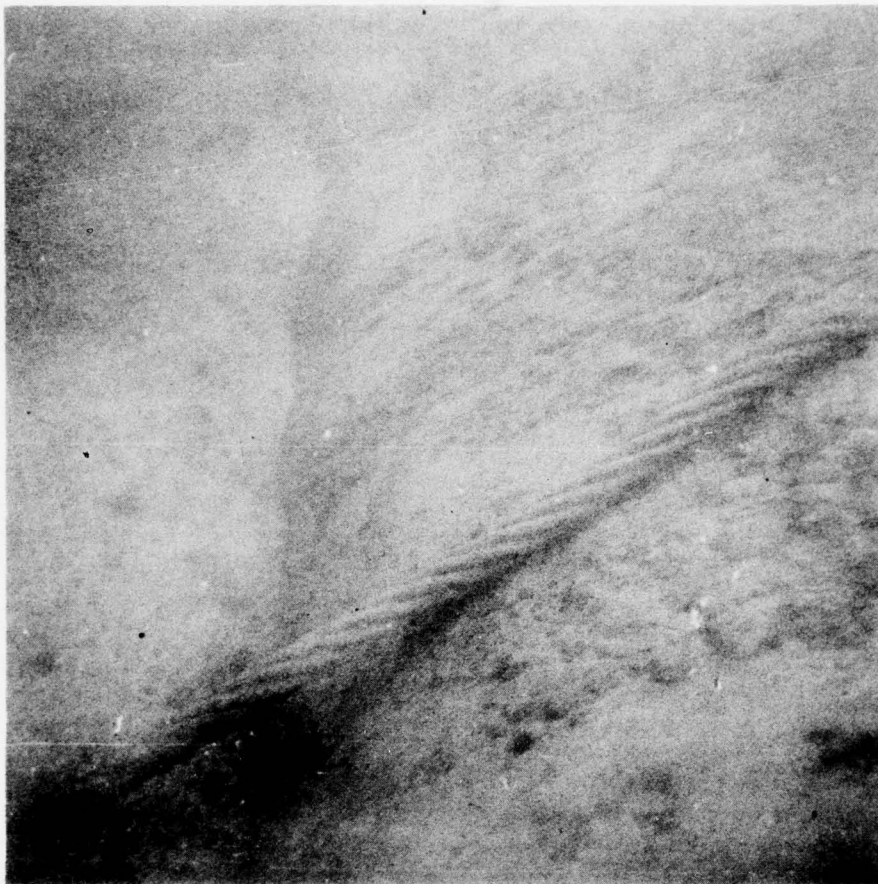
Figure 6. PILOTFISH. Dented outer shell between transverse frames, about frame No. 50. ABCR Photo No. 6040-15.

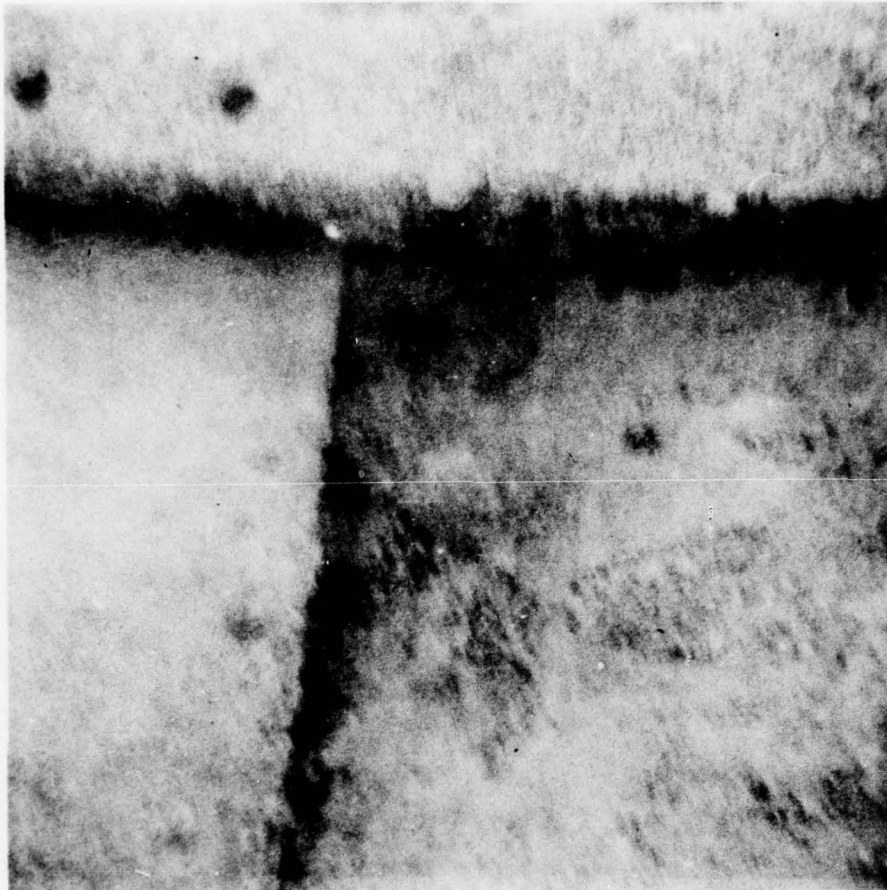
It is presumed that torpedo tubes would have been inoperable after the blast. Heavy damage in warping and cracking of tube shutters was found both port and starboard forward. It is further believed that in view of the hole in the starboard side at about frame 21, and the general denting of the pressure hull, that all six forward tubes probably were out of alignment. The after shutters, with the exception of the top edges of No. 7 and No. 8 are buried; no information was obtained about them. In view of pressure hull damage in their vicinity, however, it is surmised that the four after torpedo tubes also are out of alignment.

Figure 8. PILOTFISH. Damaged torpedo shutters on starboard side. ABCR Photo No. 6042-15.

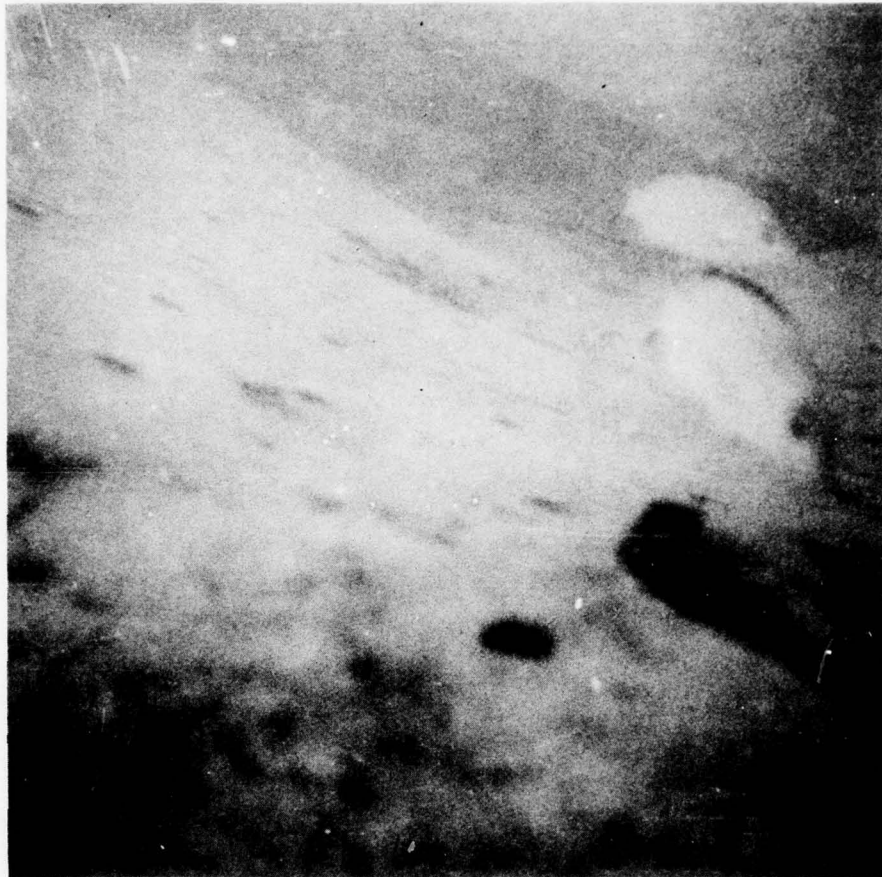
View of dent in superstructure at frame 85. ABCR Photo No. 6035-5.

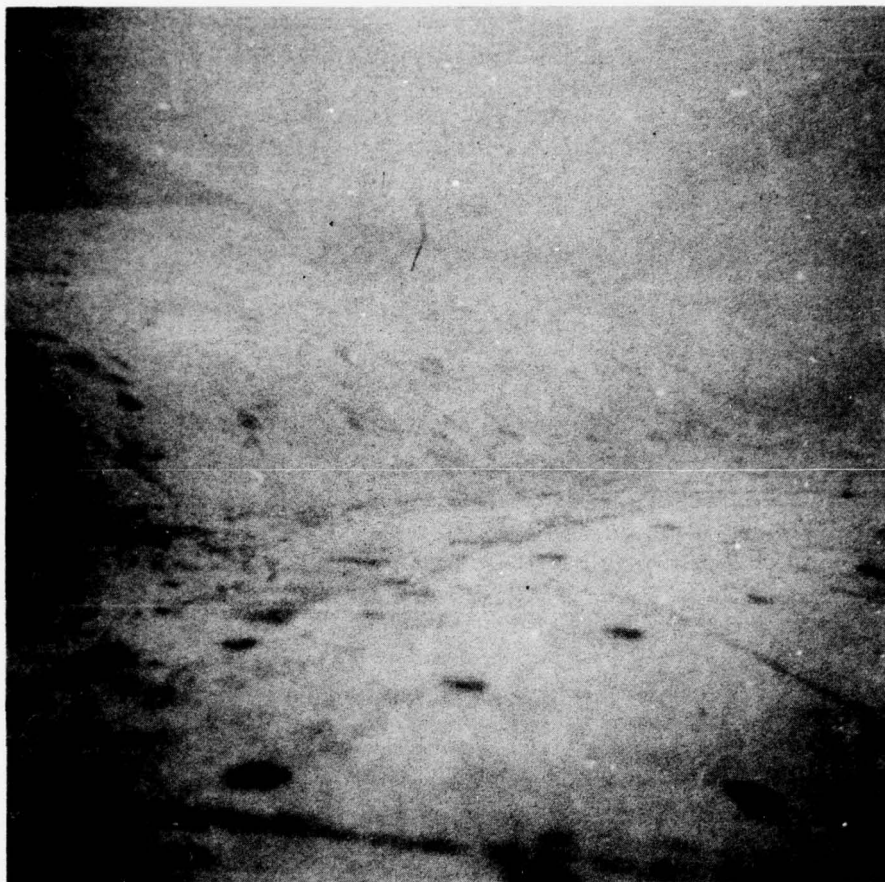
Transverse dent in superstructure forward of after engine room hatch. ABCR Photo No. 6035-6.

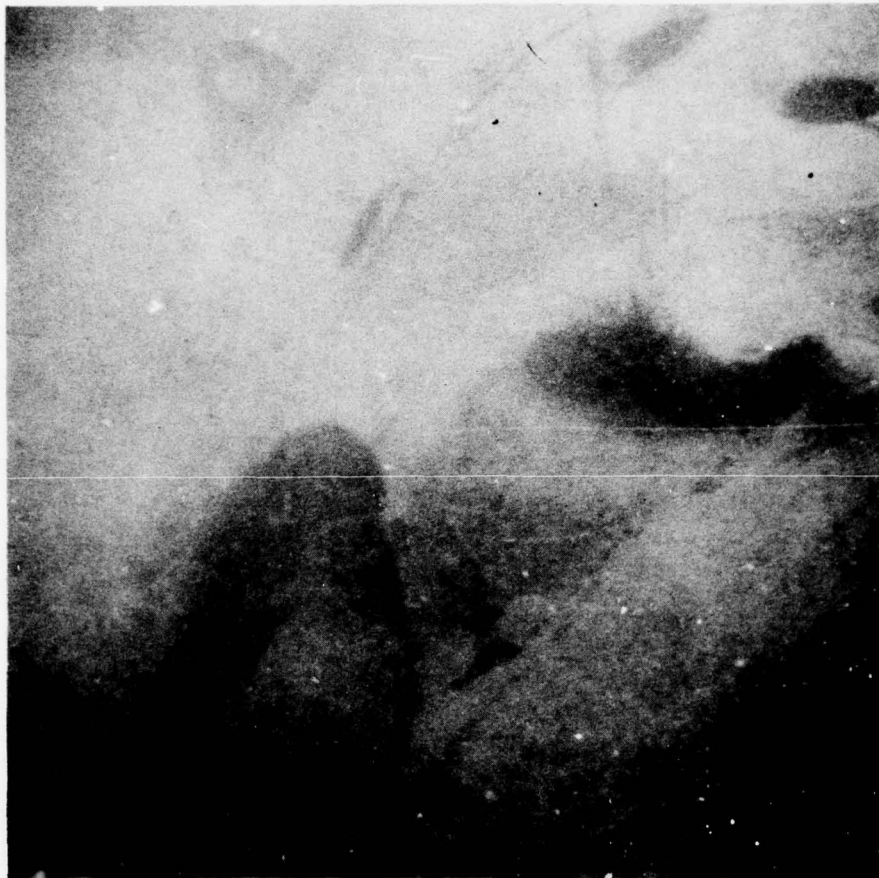
View of damage in way of after main engine exhaust, port side. ABCR Photo No. 6035-7.

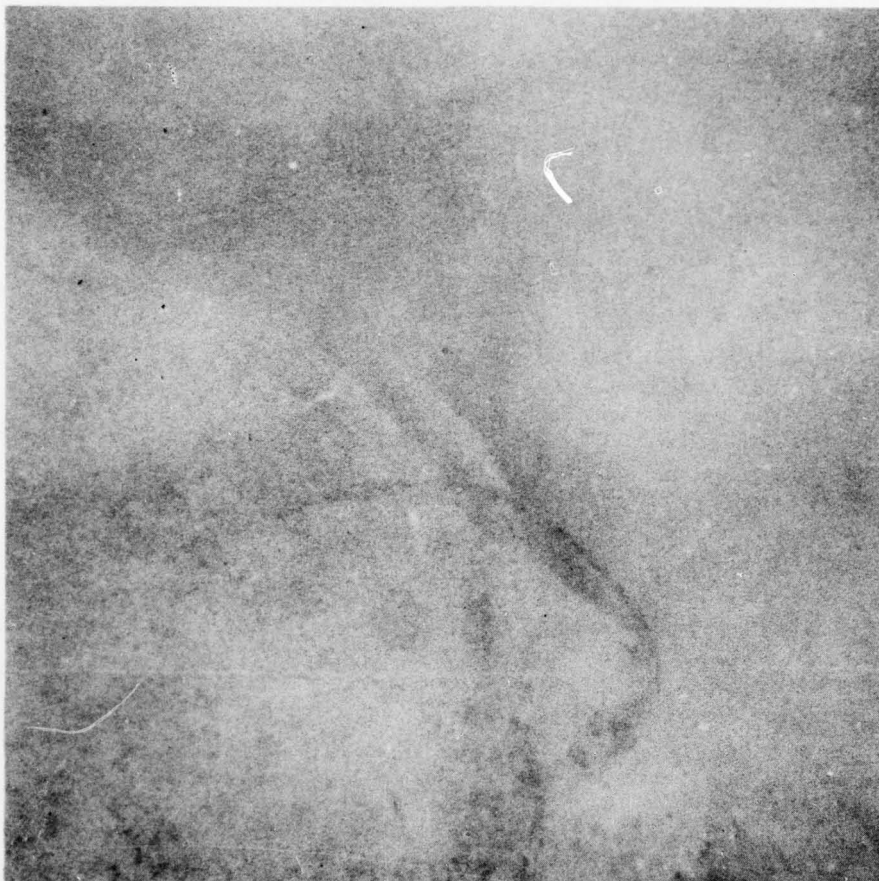
Looking down, port side of frame 121, showing dented pressure hull in way of after torpedo room, port side. ABCR Photo No. 6039-10.

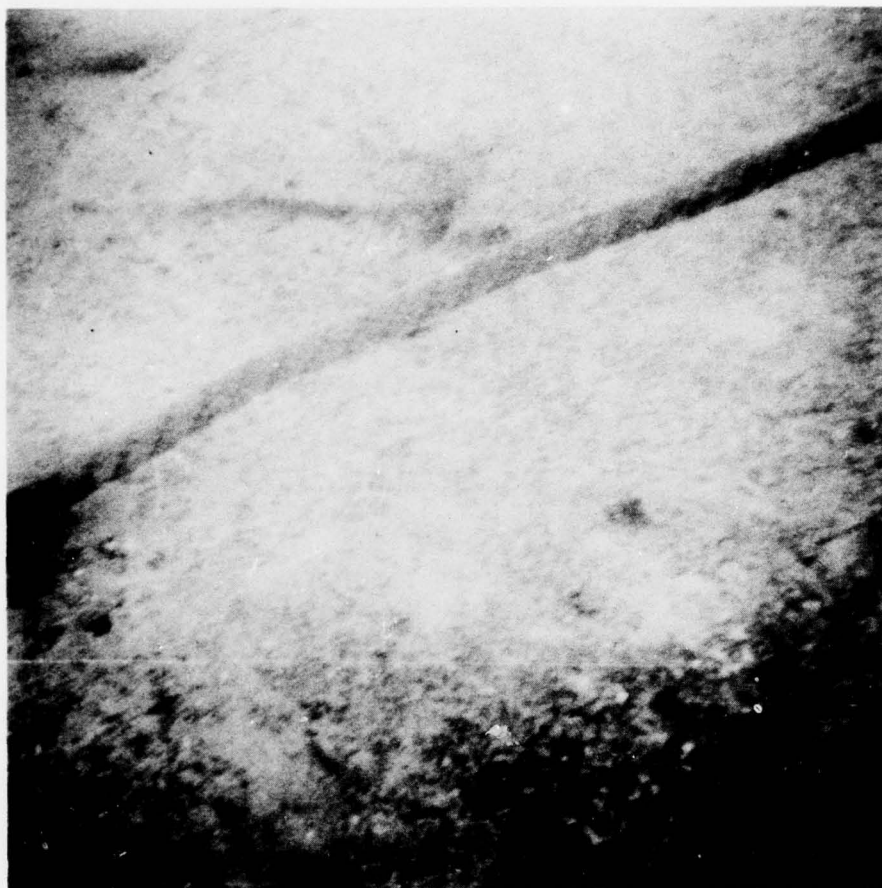
Looking forward and down on hull, about frame 109, port side, dent. ABCR Photo No. 6039-12.

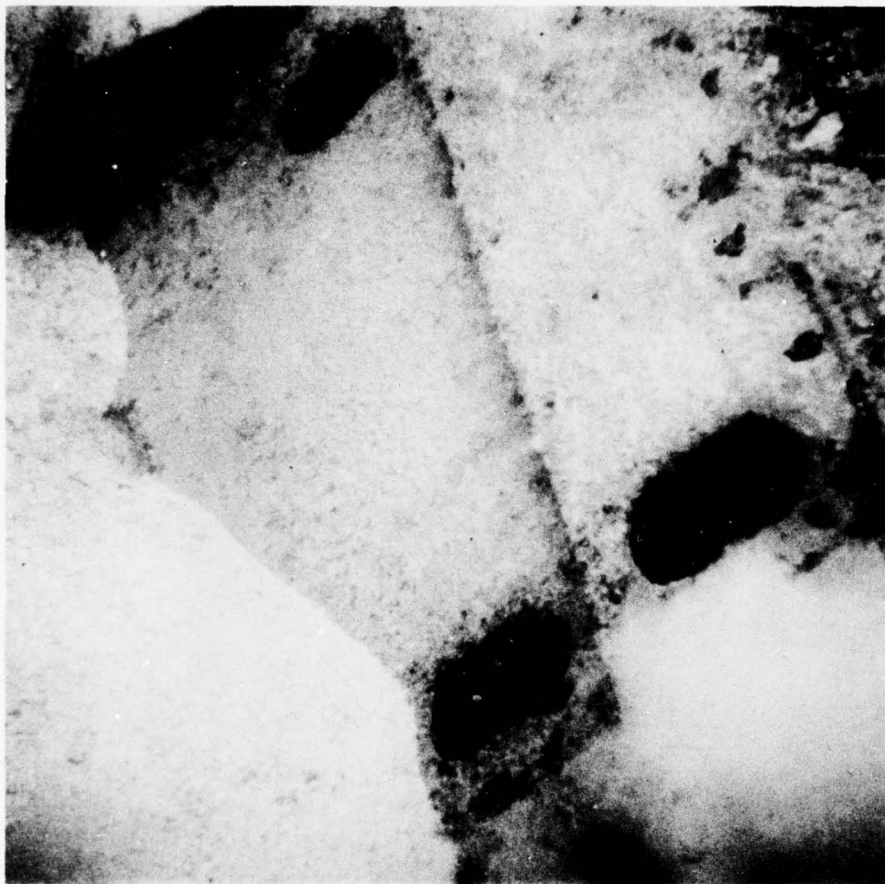
Tear in superstructure, frame 78, port. ABCR Photo No. 6039-15.

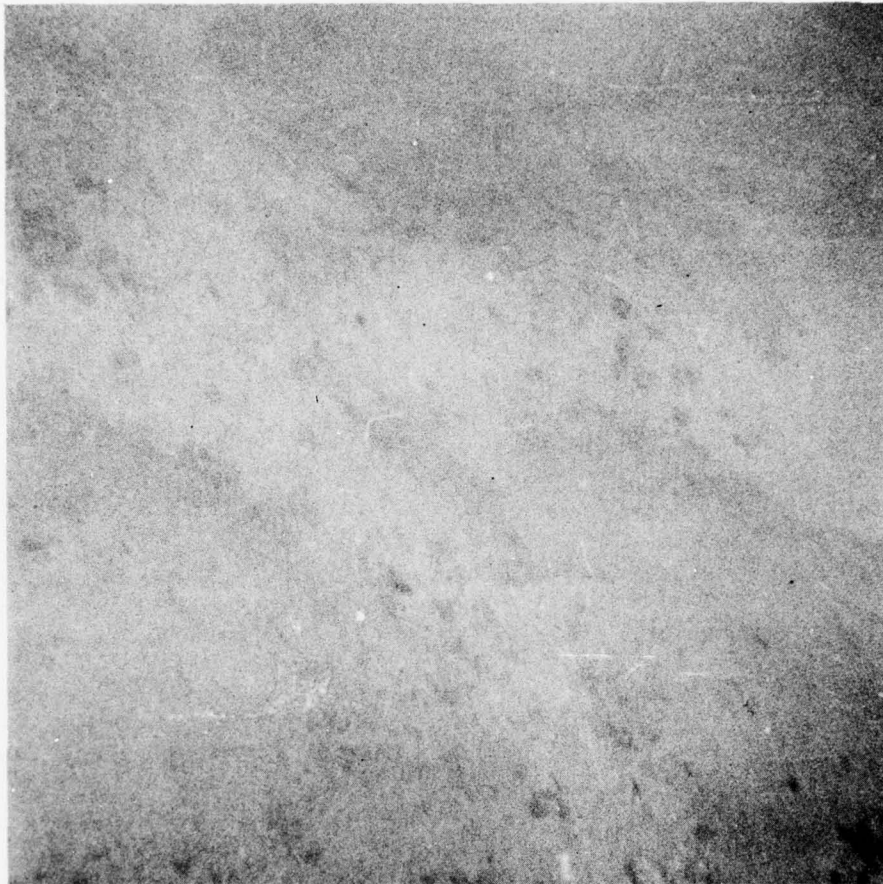
Frame 116 port side, dished in place in hull. ABCR Photo No. 6039-16.

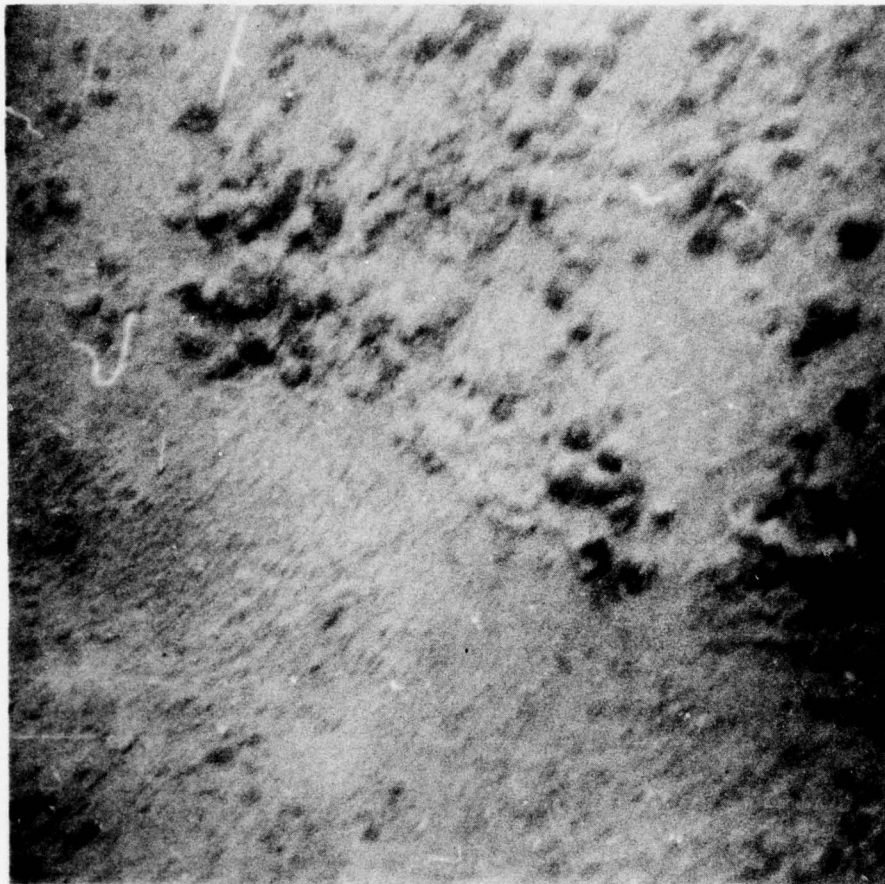
About frame 53, longitudinal dent in outer shell looking forward. ABCR Photo No. 6040-12.

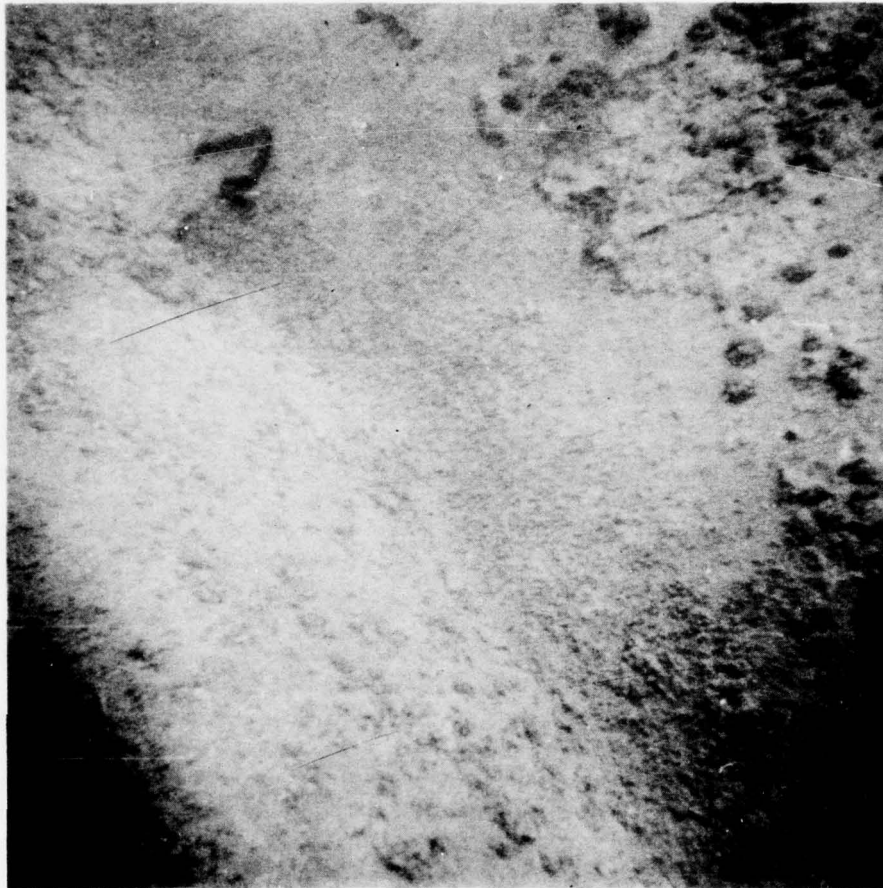
About frame 50, port side looking forward, view of longitudinal shell dent. ABCR Photo No. 6040-13.

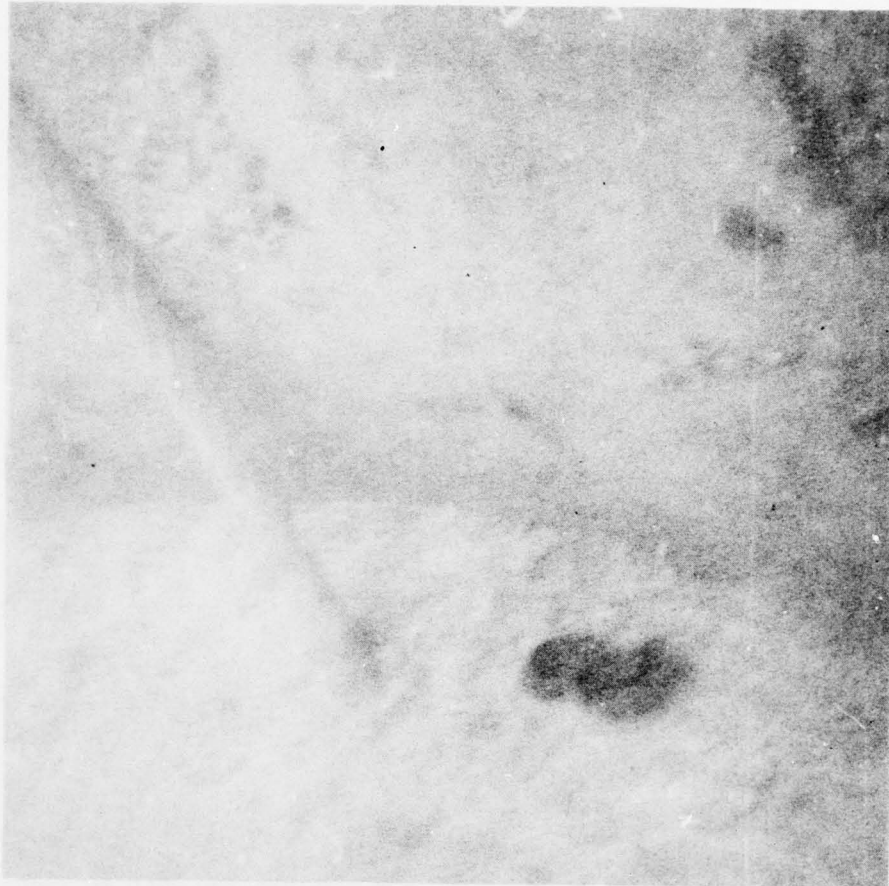
About frame 53, port side looking down on transverse dent in outer shell. ABCR Photo No. 6040-14 End.

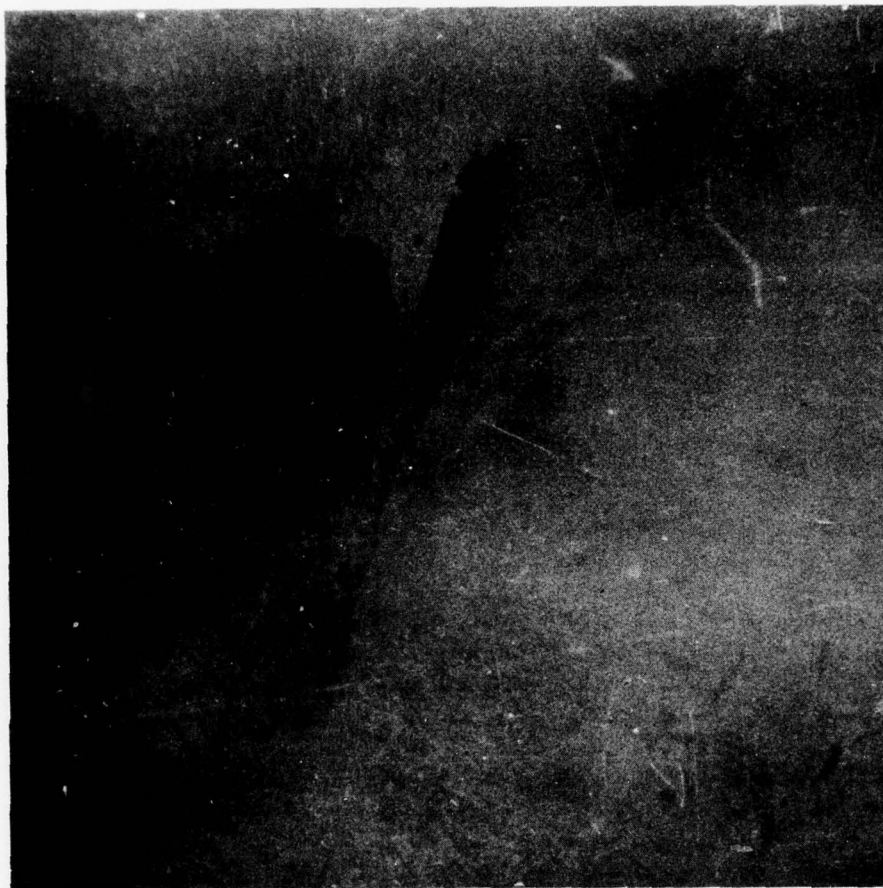
View of ruptured superstructure plating about frame 38. ABCR
Photo No. 6041-5.

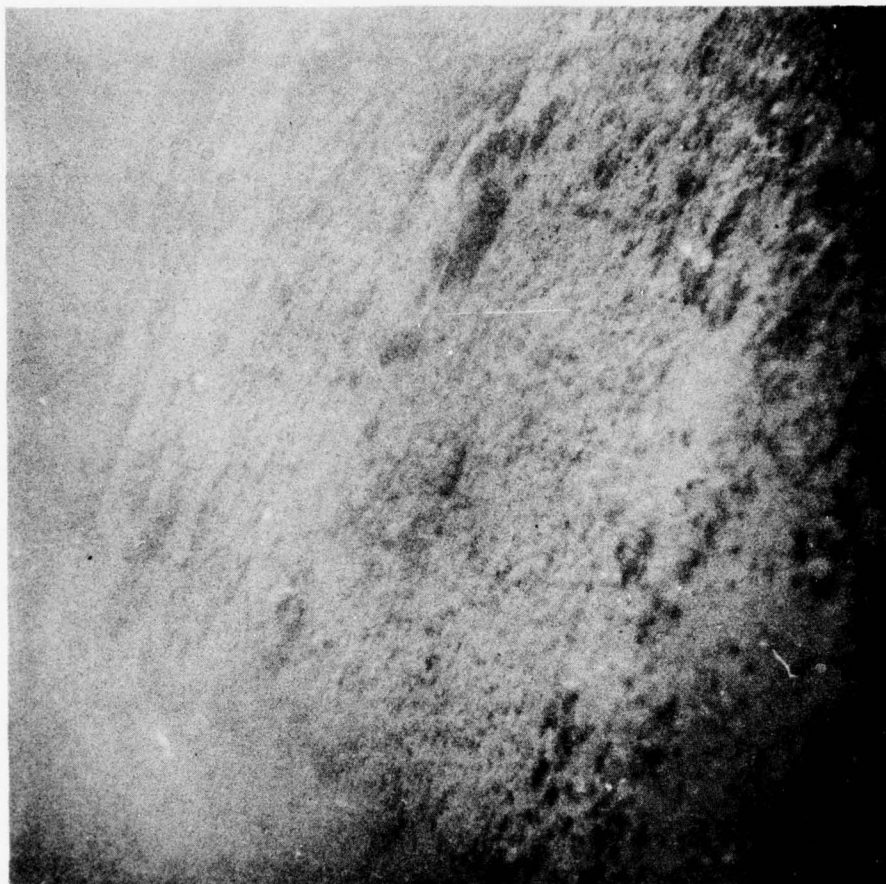
Dent in side, after part of forward torpedo room, port side,
frame 23. ABCR Photo No. 6041-6.

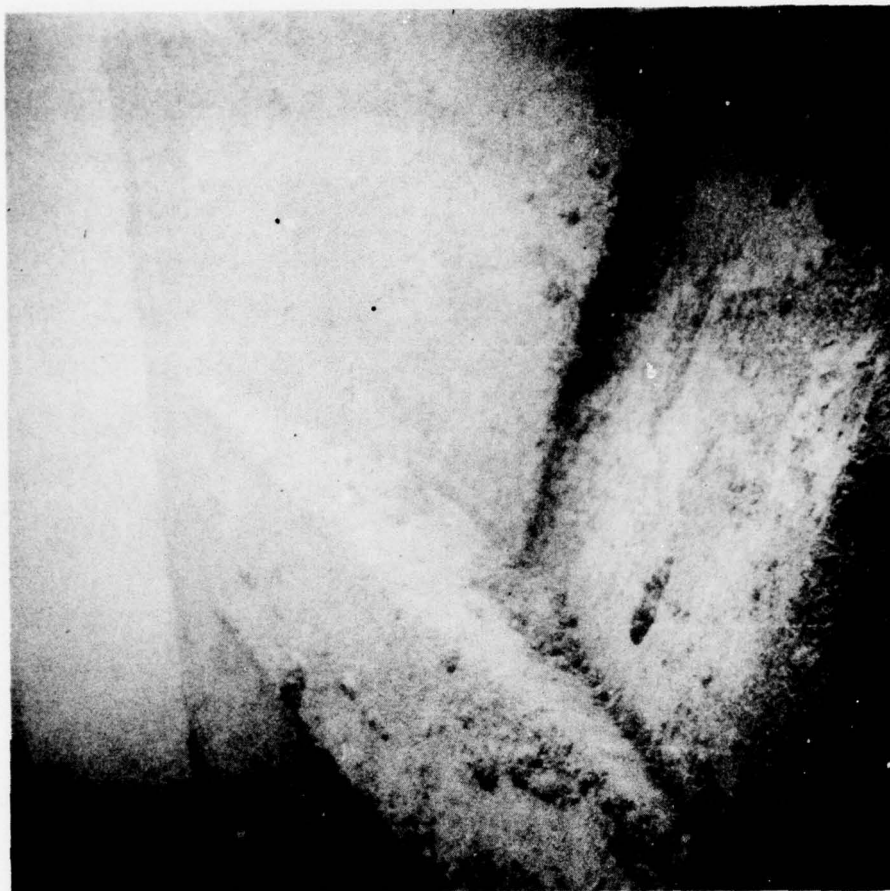
Damage in way of port torpedo shutters, port side, about
frame 7. ABCR Photo No. 6041-13 End.

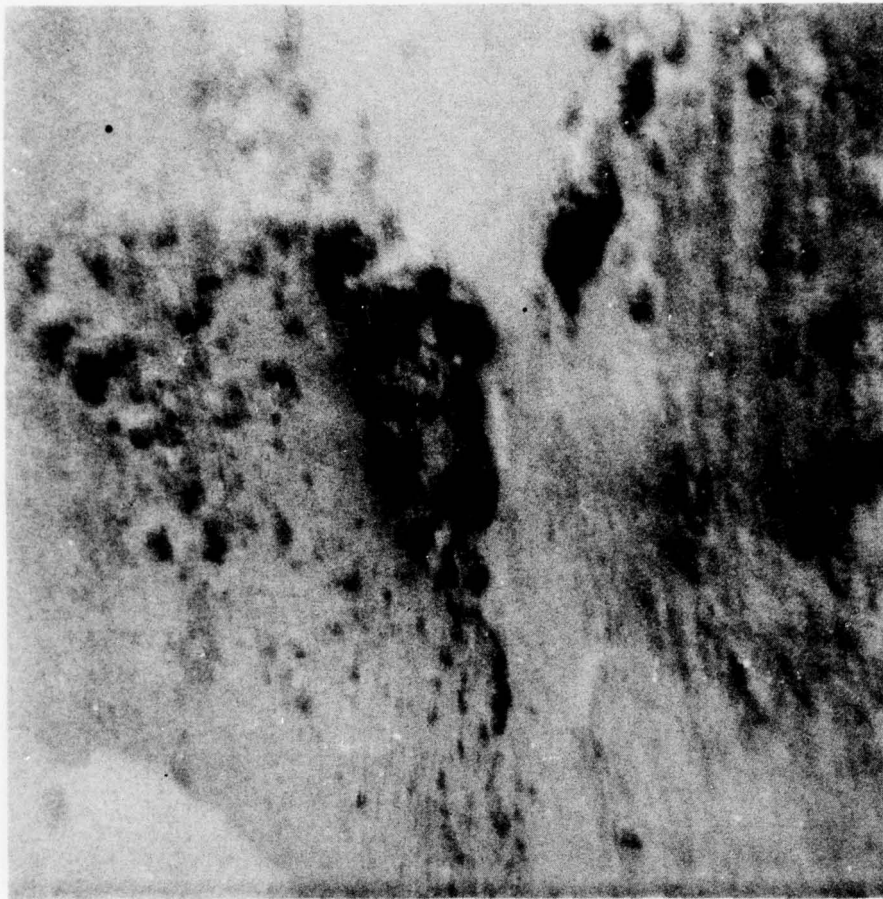
To starboard of the No. 1 gun platform, another extensive longitudinal dent was found. It ran from about frame 42 to about frame 47, and the pressure hull was torn away from "T" frames 45, 44, and 43. Frame 46 was heavily indented with the hull, and frame 43 also showed some distortion. The dent was some 18 in. deep by about 18 in. wide, with a raised section along the center about 6 in. high and rounded on top as if it had been pinched; this section of the dent ran under frames 44 and 45. No cracks were found in this general area despite presence of the heavy dent.

Frame 47, dents, port side, between frames and outer shell.
ABCR Photo No. 6042-3.

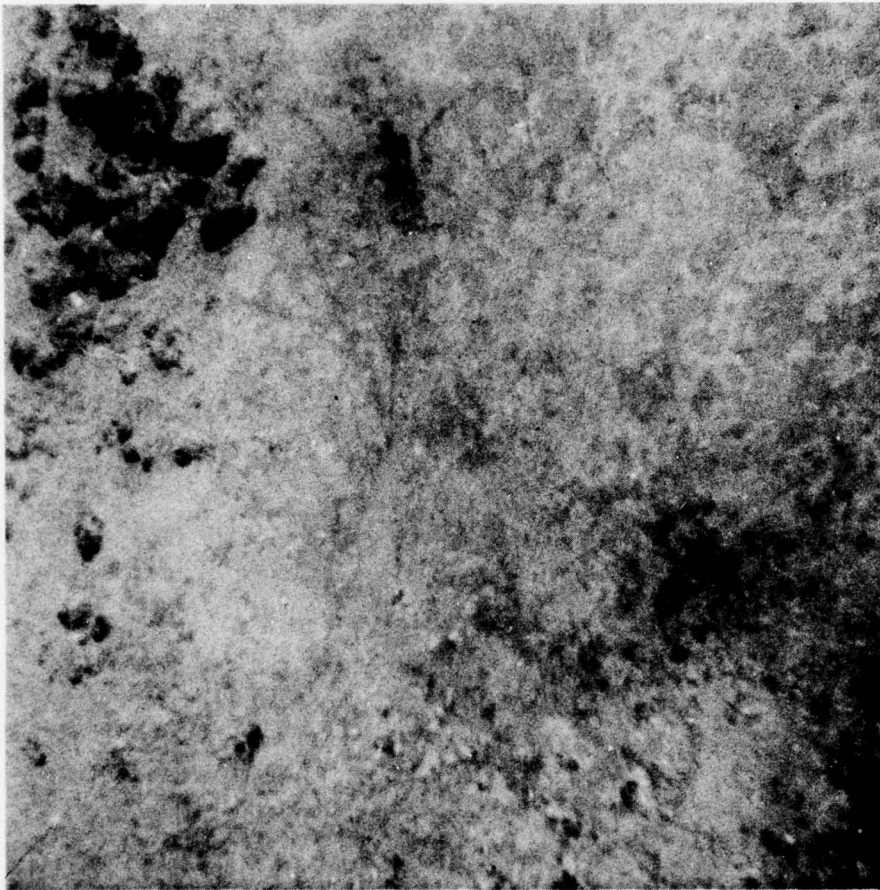
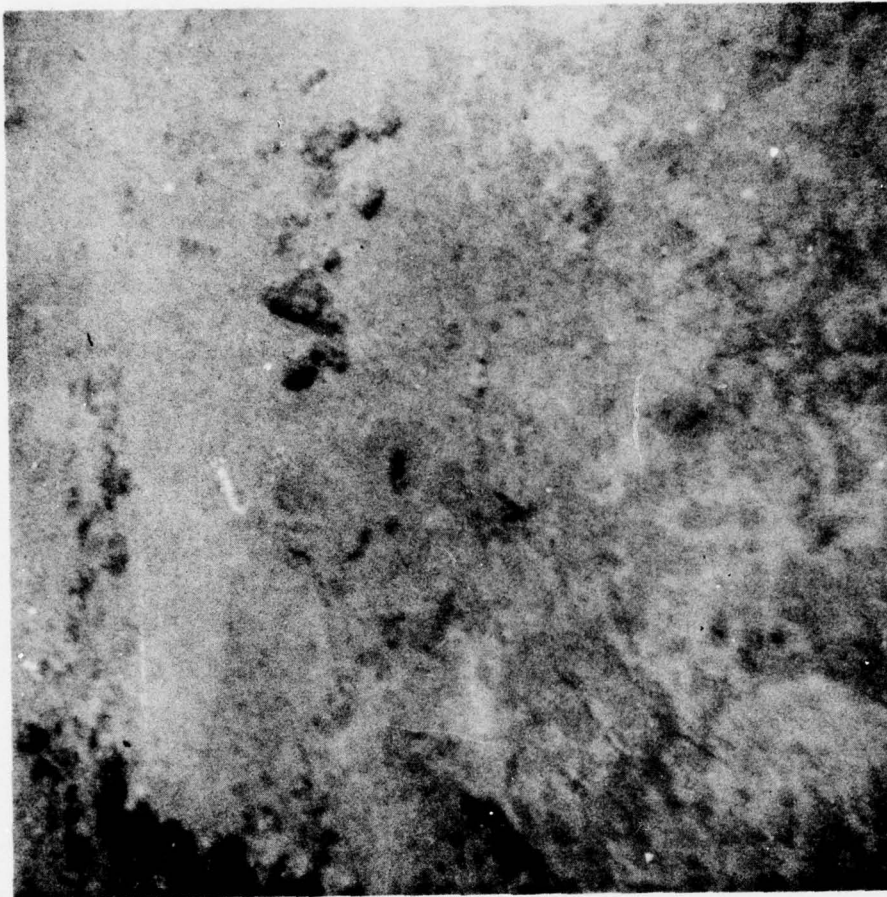
Frame 42, bad dents, port side of outer shell. ABCR Photo
No. 6042-4.

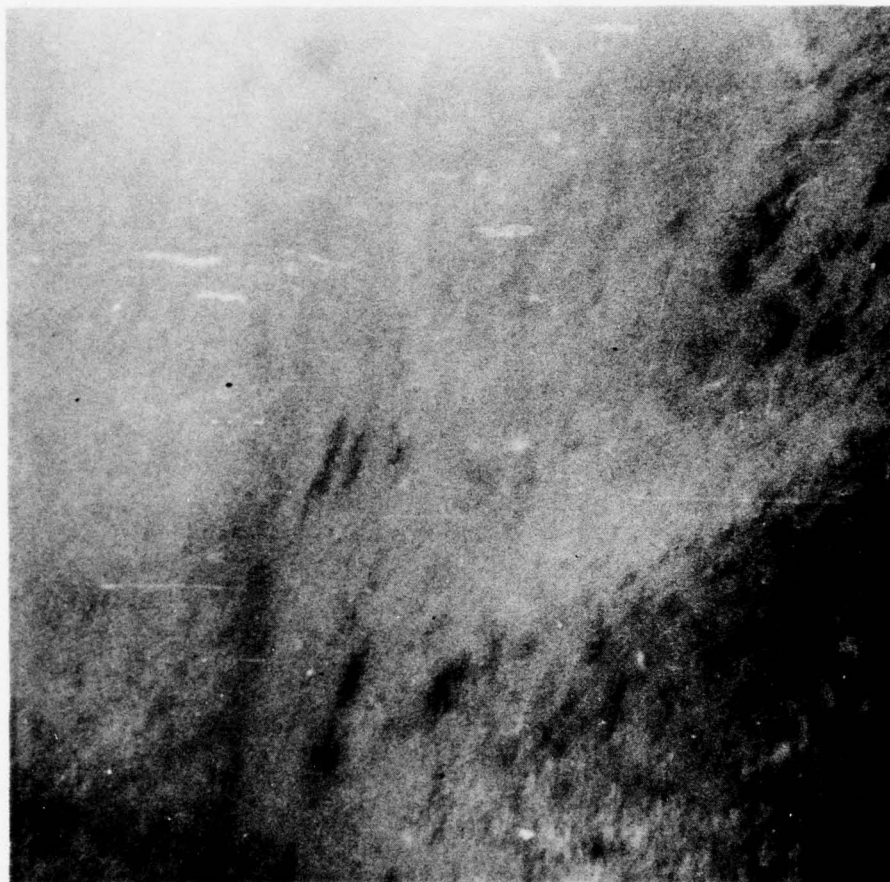
In addition to the general longitudinal and transverse dishing along the sides of the vessel, a dent about 18 in. deep was found in the port side from about frame 24 to about frame 36, with a crack $\frac{1}{2}$ in. wide from the dent to the superstructure at about frame 20. The dent in question was located above the bottom and about 5 ft. to 6 ft. below the superstructure. A vertical crack about 4 in. wide and about 3 ft. to 4 ft. high was found at about frame 10 in. the bow buoyancy tank.

View, frame 30, port side, sharp longitudinal dent, about 18 ins deep, looking forward. ABCR Photo No. 6042-9.

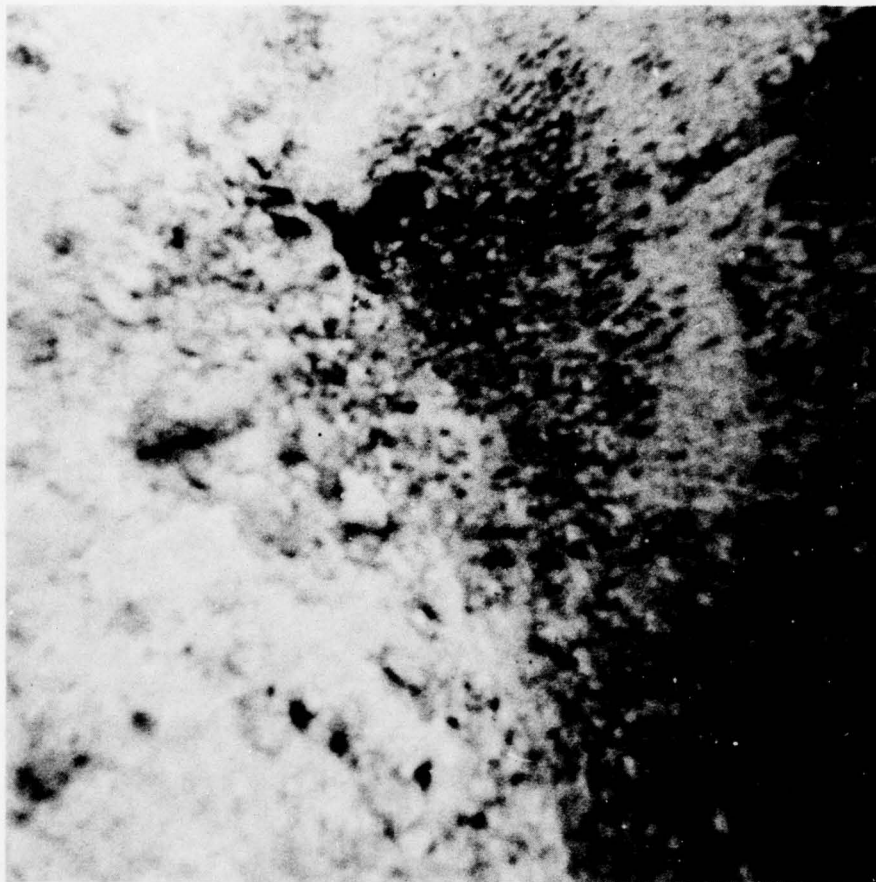
View, frame 30, port side, sharp longitudinal dent about 18 in. deep, looking forward, showing crack in shell. ABCR Photo No. 6042-10.

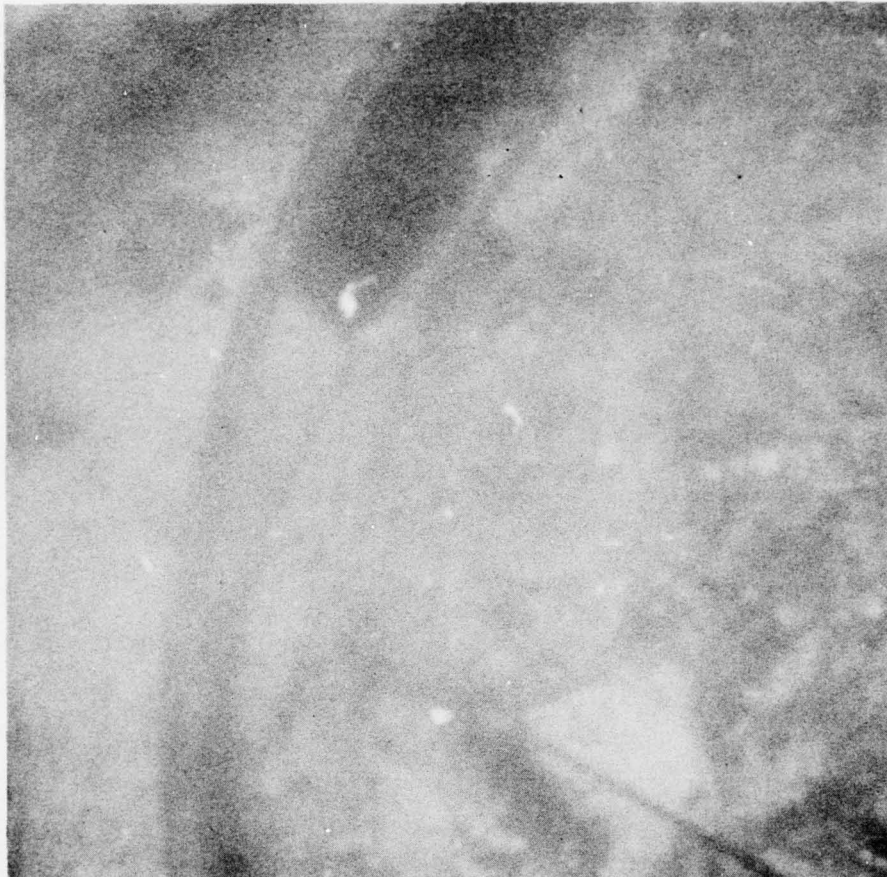
Ventilation was destroyed. The main induction valve was heavily wrinkled, but no cracks were located. The valve top was moved 2 to 4 in. off its seat to port and aft, and divers were able to get their fingers between the top and the seat almost all the way around the top. The retainer ring and gasket both failed to such an extent that a section of the gasket about 6 in. to 8 in. long was completely out of the groove.

View of main induction valve looking down showing displaced top on seat. ABCR 6046-8.

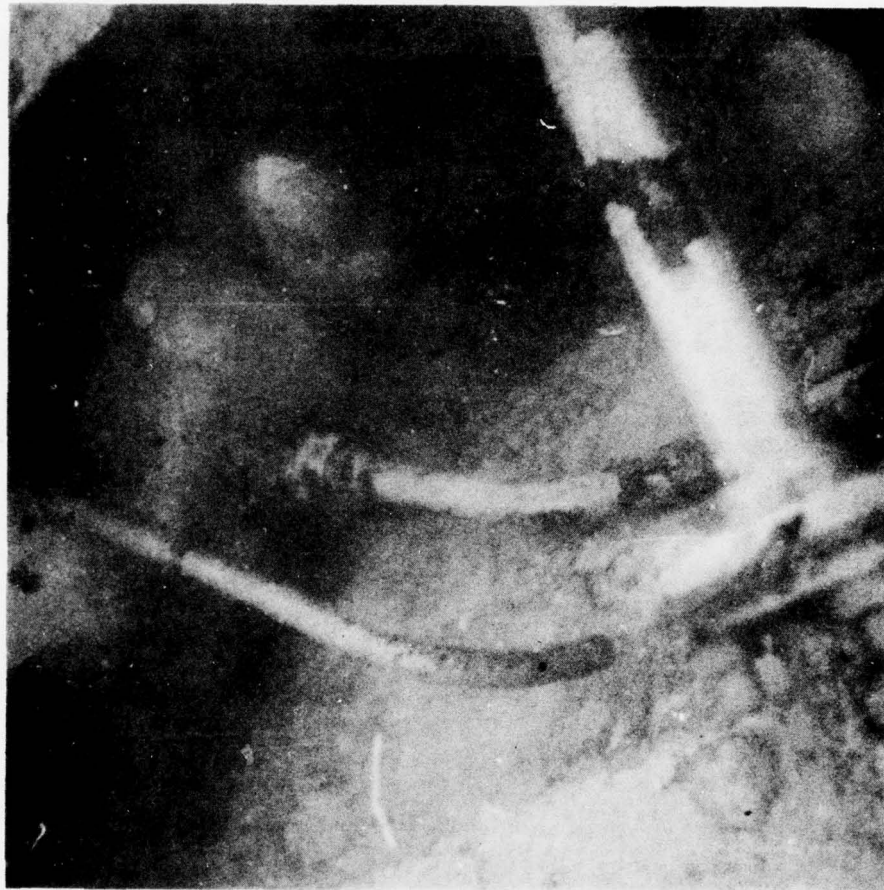
View of one sound and one ruptured line, presumably hydraulic
and piping believed to be 10 pound blow, about frame 82.
ABCR Photo No. 6047-5.
